12TH INTERNATIONAL
BRICK/BLOCK
Masonry
CONFERENCE

Madrid, 25-28 Junio 2000

**CHARACTERISTICS OF THE AUTHENTICITY AND
SUSTAINABILITY IN THE PRESERVATION OF
TUFF MASONRY**

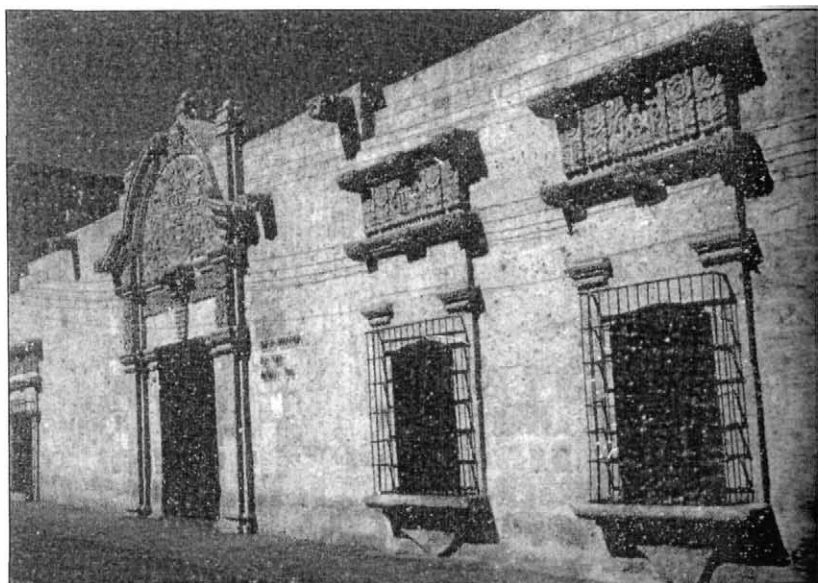
Figure 1.

Another point to consider is that, the Spanish technology transference of stone masonry was possible due to the abundant material existing there and to the lack of forests in that area. The massive construction of double leaf walls and barrel vaults to cover not only great spans but also small ones was significant in civil, residential and religious works giving rise to the mixed baroque style of Arequipa with its singular carved façades (Fig. 1 Casa del Moral s XVIII).

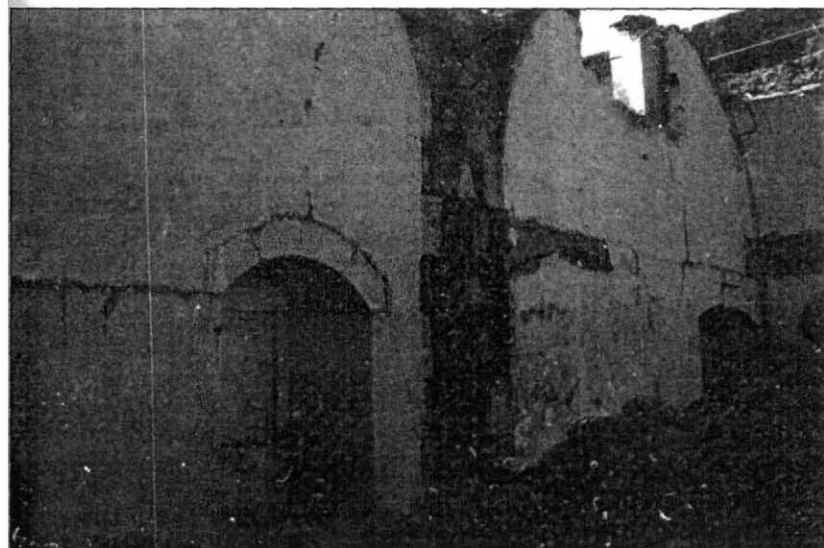
Figure 4.

Obviously, the insertion of framed structures has transformed the mechanical behaviour of the old stonework, but it has been an option to increase the user's security and the resistance to the continuous earthquakes. The use of beams acting as tie beams in the headwalls has been a normal practice, as well as installing corrugated iron rafters for bracing the load bearing walls, casting columns in the

work stone corners, placing sheaths (Fig. 5 finished roof brick tiles) and ribbed arches in the extrados of the barrel vaults and domes, and introducing lintels and other small interventions in mass concrete.

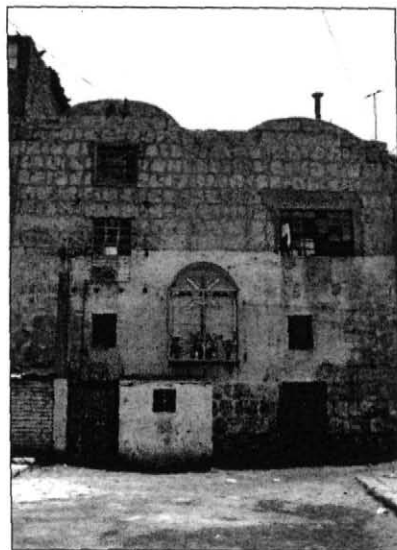
Figure 6.

In the partition walls good use has been made of the existing storing spaces and of the niches of arches of the kitchen chimneys to introduce the toilets in both houses and commercial premises. In cases where these spaces were not available new openings not higher than 2m, have been introduced eliminating one leaf of work stone as well as the stone and mortar filling.

In order to increase the light, there has been no other alternative than to broaden the spans or to open them where they were necessary. In order to increase the occupation density, the height of the room has been divided with a slab which spreads to one of the headwalls only creating new windows when possible (Fig. 6). In one-storey houses, it has been necessary to eliminate one of the headstones of the vaults to ensure zenithal light.
